# Manhole Inspection Summary

Manhole # S21UU1028MH

Insp Date: **7/22/08 1:15 PM**

**Location** Address: **CROSS KEYS RD**

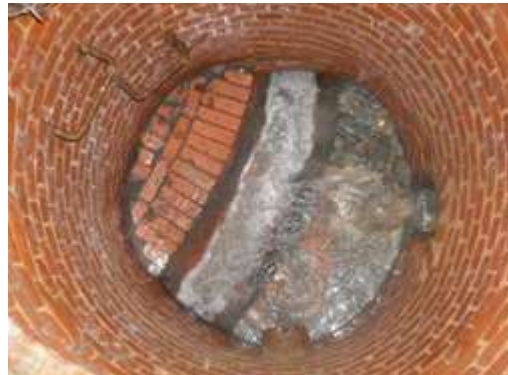
Top View

**Bench** ☒ Exists Material: **Brick** ☐ Parged ☒ **Debris** (not Condition related)

**Steps** Count: **3** Missing: **0** ☒ **Corroded**

**Surcharge** ☒ **Evidence Of Surcharge** Depth: **4.5** (ft.) ☐ Active Surcharge Present

Corroded steps. Evidence of surcharge - Bench debris.

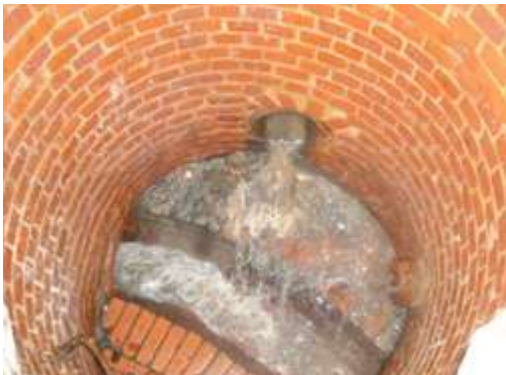
Defect

Infiltration: ☐ None ☐ Joint ☐ Cracks ☐ Mortar ☐ Roots ☒ **Wall**

Barrel infiltration.

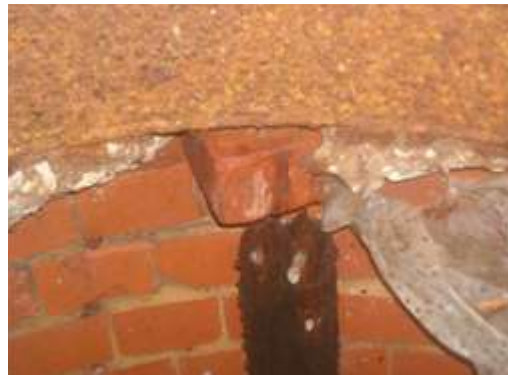
Defect

Condition: ☐ Sound ☐ Cracked ☐ Root Intrusion ☒ **Loose Brick** ☐ Deteriorated

Infiltration: ☐ None ☒ **Joint** ☐ Cracks ☐ Mortar ☐ Roots ☐ Wall

Adjustment loose brick and infiltration.

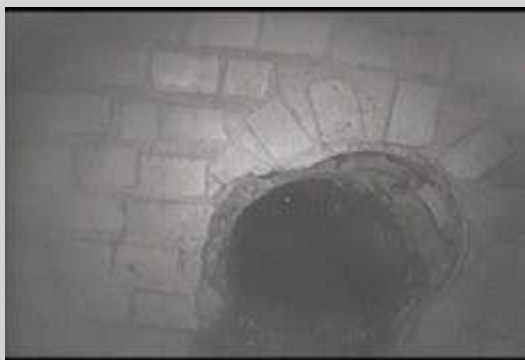
### 10 in. Circular Gravity Sewer Pipe In @ 3 O'Clock

Infiltration: **None** Pipe Seal Cond: **Broken**

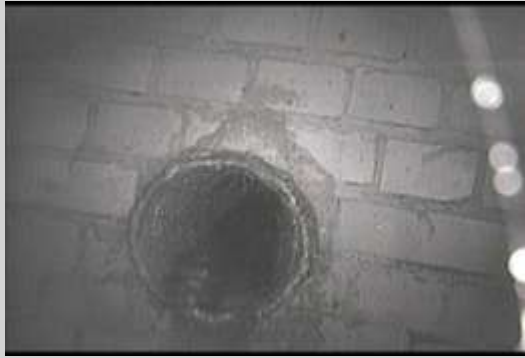
### 6 in. Circular Gravity Sewer

Deposits: ☐ None ☐ Mud ☒ **Sludge** ☐ Debris ☐ Grease

Silt Depth: **1** (in.) Deposits Extent: **Light**

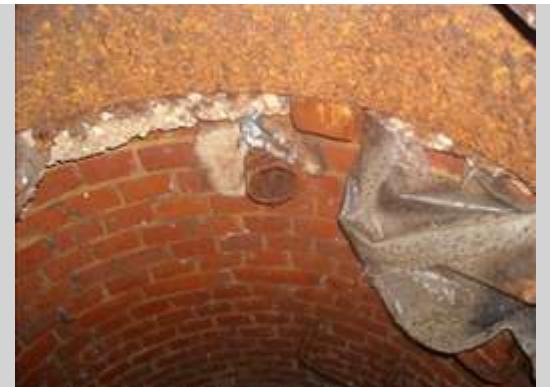
Pipe In @ 9 O'Clock

Possible illicit connection.

Connects To: **Stub connection / abandoned**  
☒ **Possible Illicit Connection**
